Navajo Abandoned Uranium Mine

Site Screen Report

Mine Name: Kachina No. 6
Mine ID: 230

August 2011

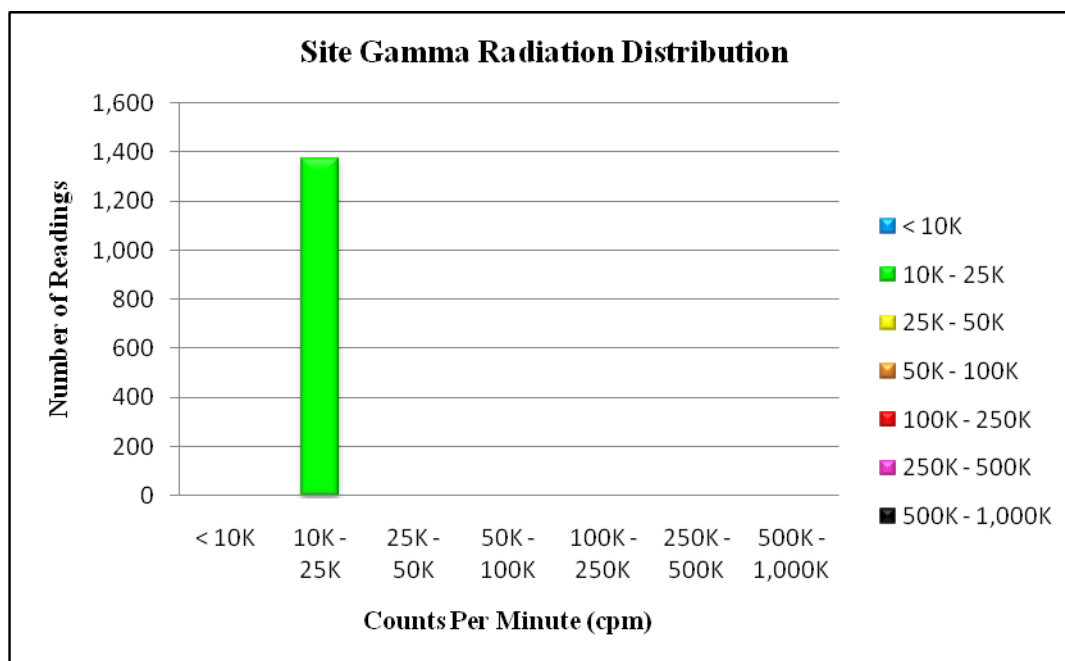
Distribution Chart and Statistics:

Site Gamma Radiation Statistics	
Number of Readings	1,375
Minimum (cpm)	10,700
Maximum (cpm)	19,787
Mean (cpm)	15,452
Median (cpm)	15,521
Standard Deviation	1,102

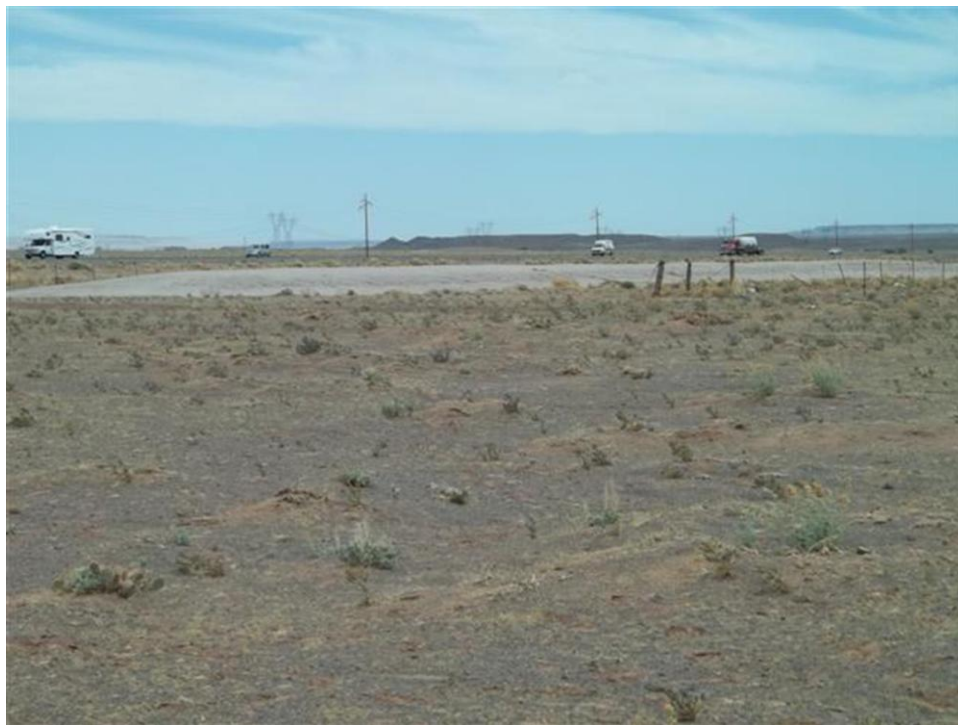
Photo 1: Mine Site #230; Site and Hwy 89

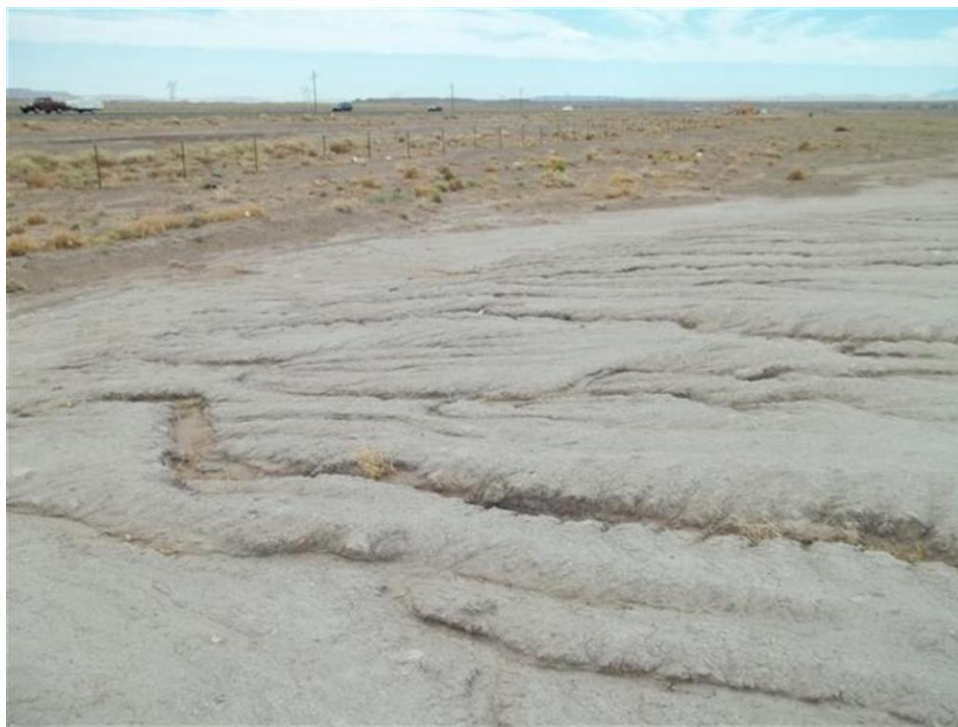
Photo 2: Mine Site #230; Mound area

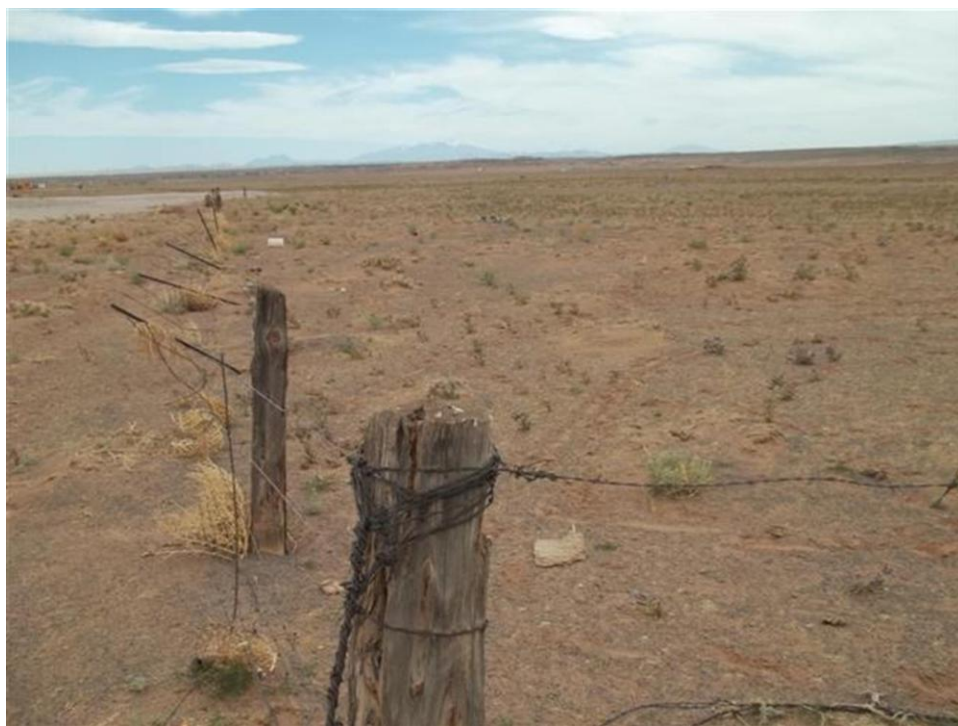
Reclamation cap in center/north part of site; fenced area in NW part of site

Photo 3: Mine Site #230; Fenced area

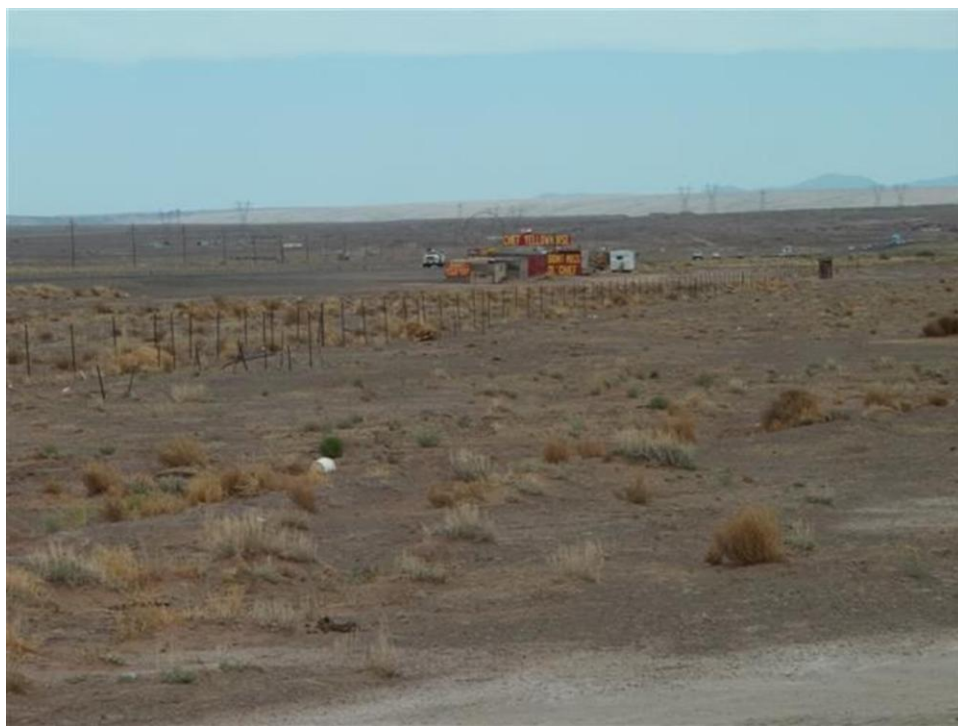
200 feet to 0.25 mile: Chief Yellow Horse vendor stand 0.2 mi S of site

Photo 4: Mine Site #230; Vendor stand south of site

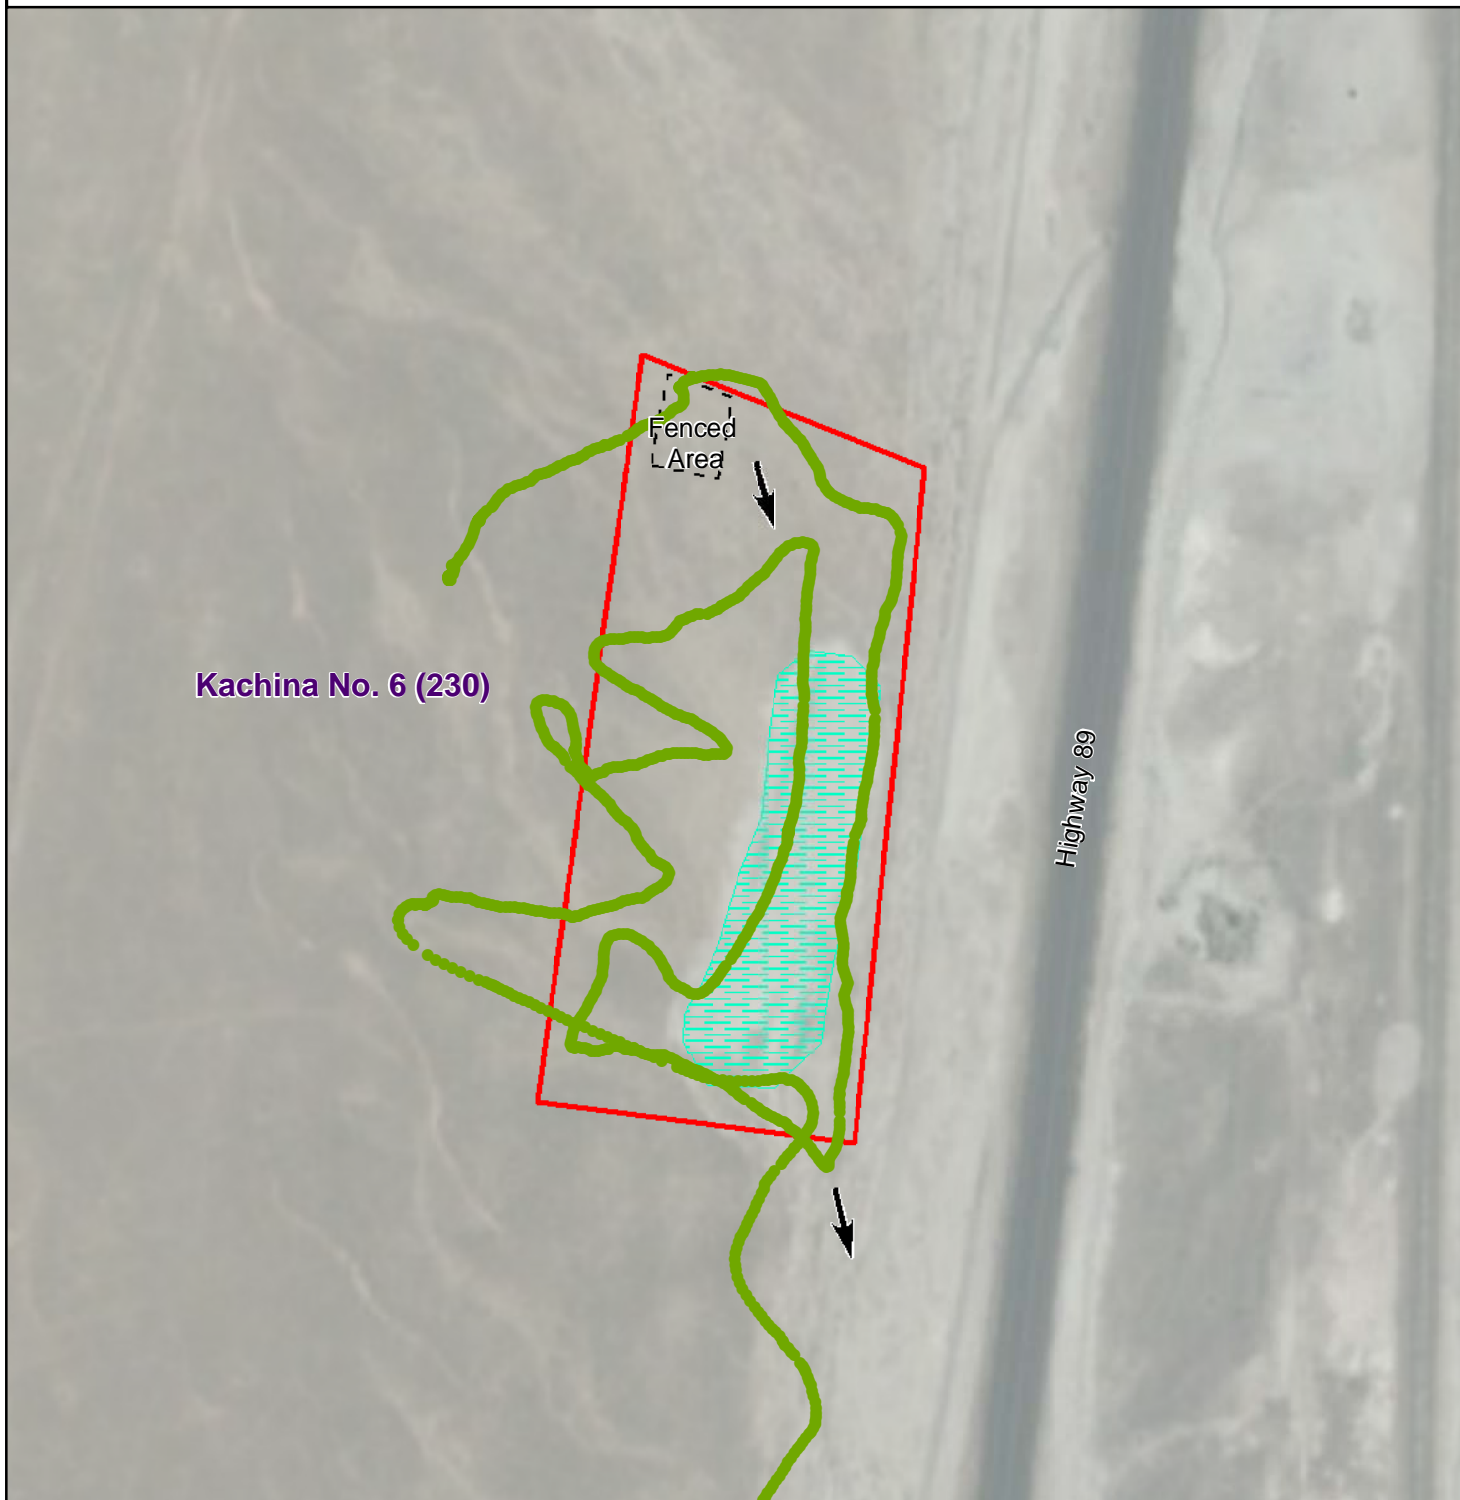
Highest gamma radiation measurement: 19,787 counts per minute (cpm)

Background Average: 10,730 cpm **Two Times Background:** 21,460 cpm

A total of 1,375 gamma radiation measurements were collected from the mine site, ranging from 10,700 cpm to 19,787 cpm. The measurements are represented in Figures 1 and 2.

**Figure 1 - Gamma Radiation Measurements, Above Two Times Background
Kachina No. 6 (230)
Coalmine Mesa Chapter, Navajo Nation**

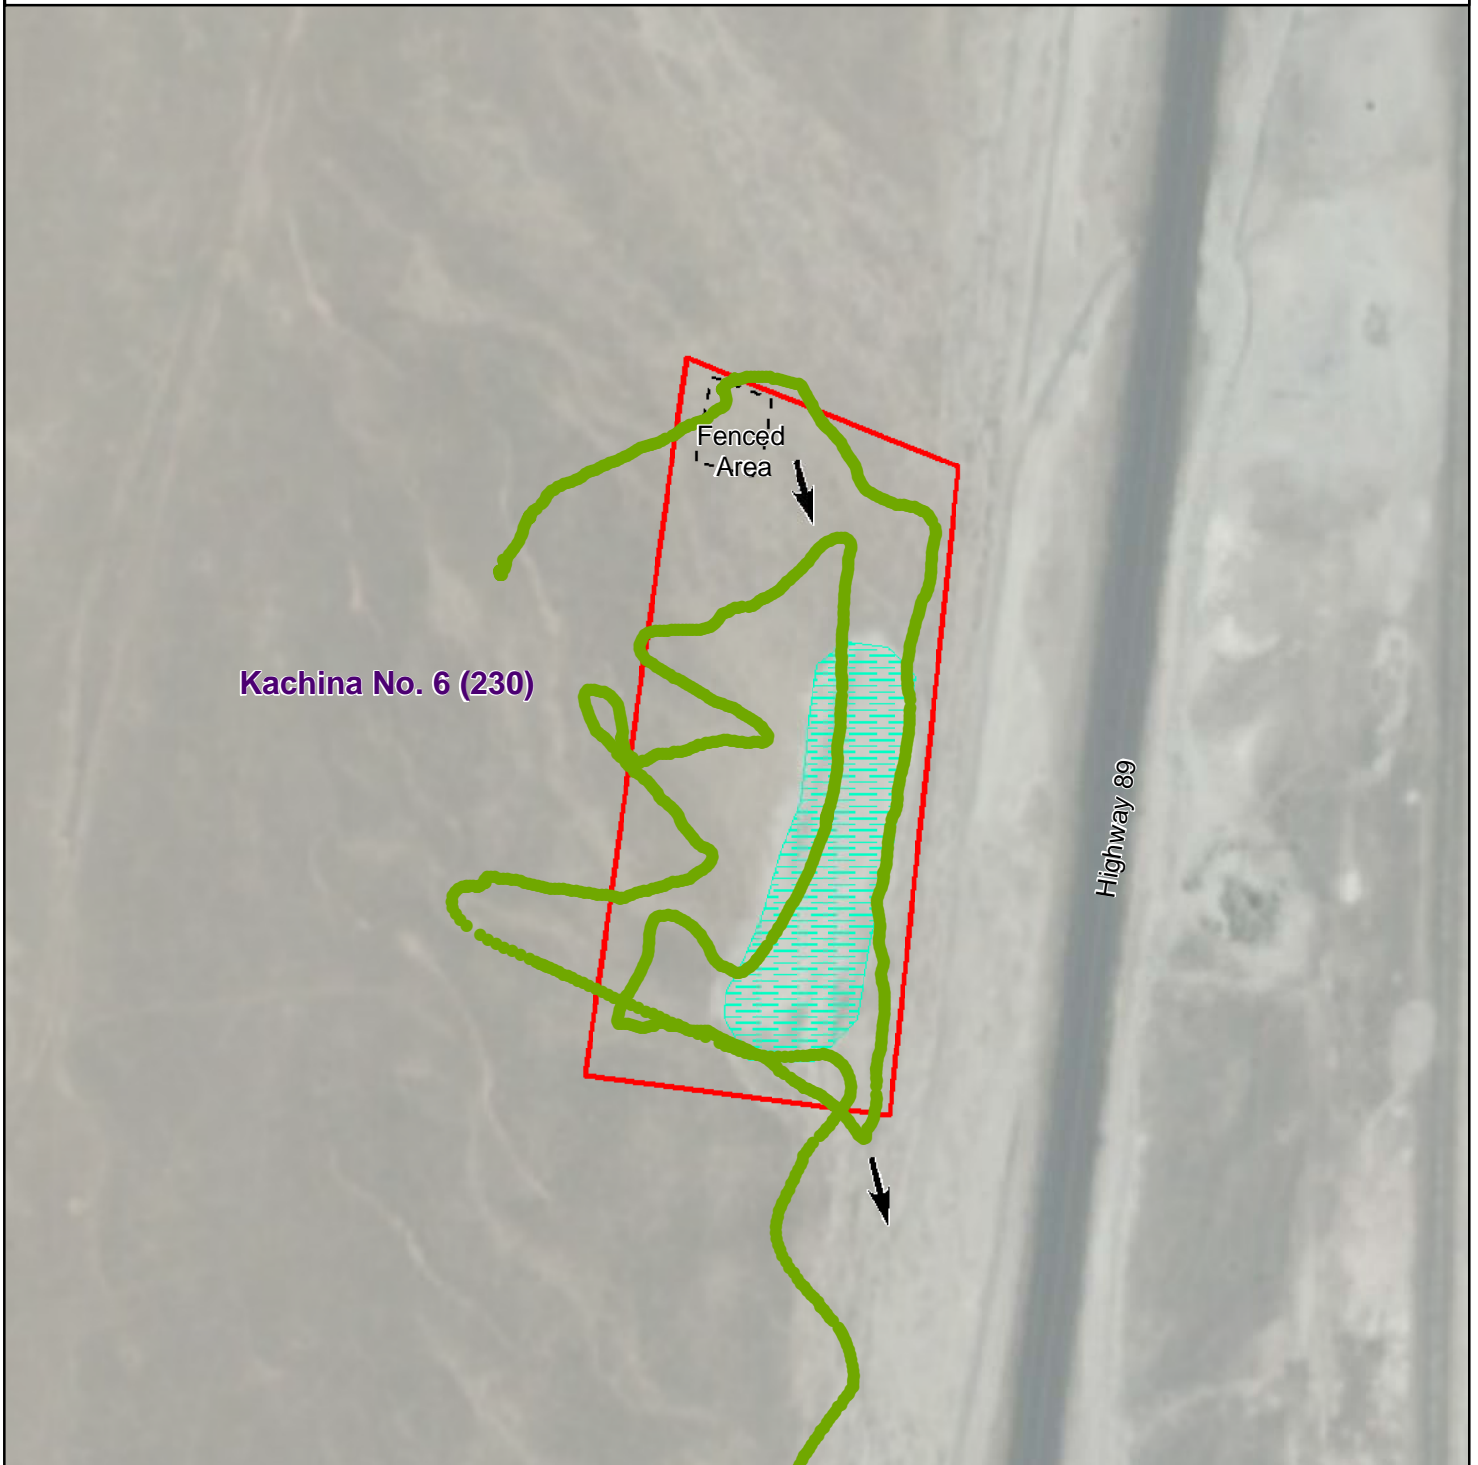
**Figure 2 - Gamma Radiation Measurements
Kachina No. 6 (230)
Coalmine Mesa Chapter, Navajo Nation**

Measured as counts per minute (cpm) Average background 10,730 cpm
